Deepwater Horizon – Summary of Critical Events, Human Factors Issues and Implications

23 Sept 2010

Deepwater Horizon – Summary of Critical Events, Human Factors Issues and Healthcare implications

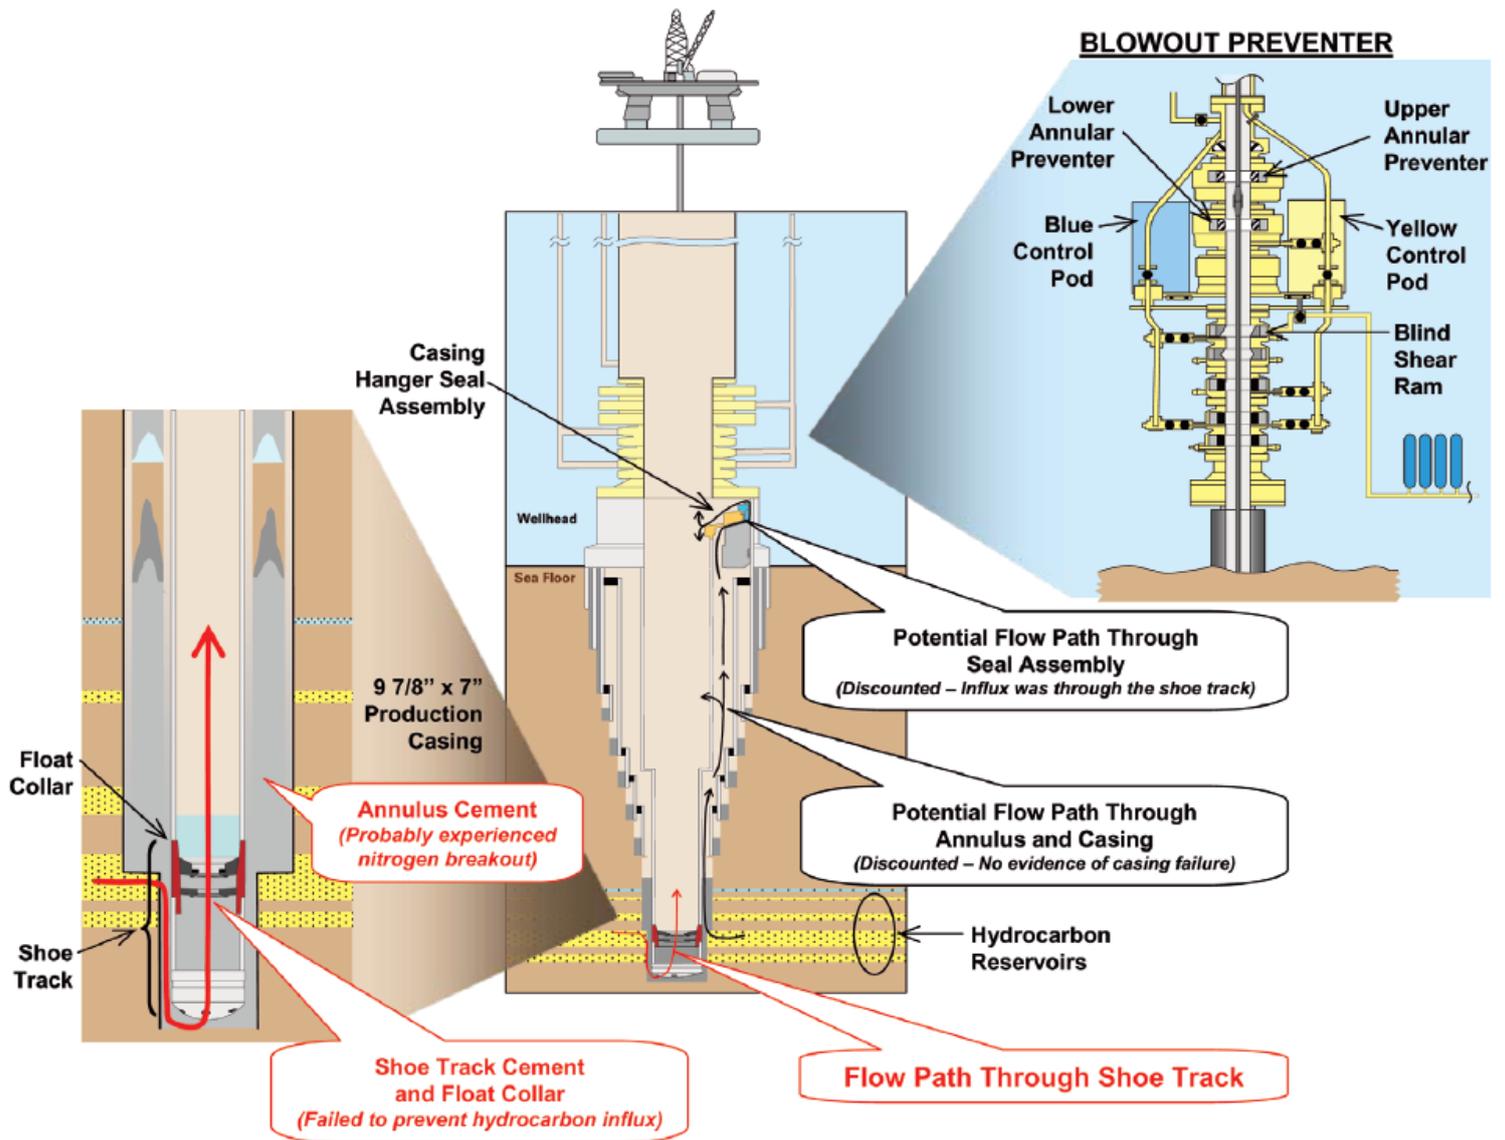
Figure 1: The Macondo Well

The Deepwater Horizon drilling rig was stationed in the Gulf of Mexico for exploratory drilling on the Macondo well. The drilling rig is a mobile, temporary rig that drills the well, identifies that there is a viable reservoir of hydrocarbons, and then makes it safe and ready for a more permanent production rig. This involves drilling a deep bore hole in stages and filling the casing with cement. Figure 1 gives a picture of the Macondo Well taken from the accident report. This shows the cement barrier which failed and allowed hydrocarbons and mud from the reservoir to escape through the drill pipe (the main pipe through the middle section). The accident report describes test procedures that the crew were carrying out. These involve the kill and fill lines which can be seen as the small pipes that join the drill pipe at the blow out preventer. The blow out preventer (BOP) is a shut-down device that can cut off liquid flow using either the annular preventer, which can slow or stop the flow, or the blind shear ram, which shuts it off completely.

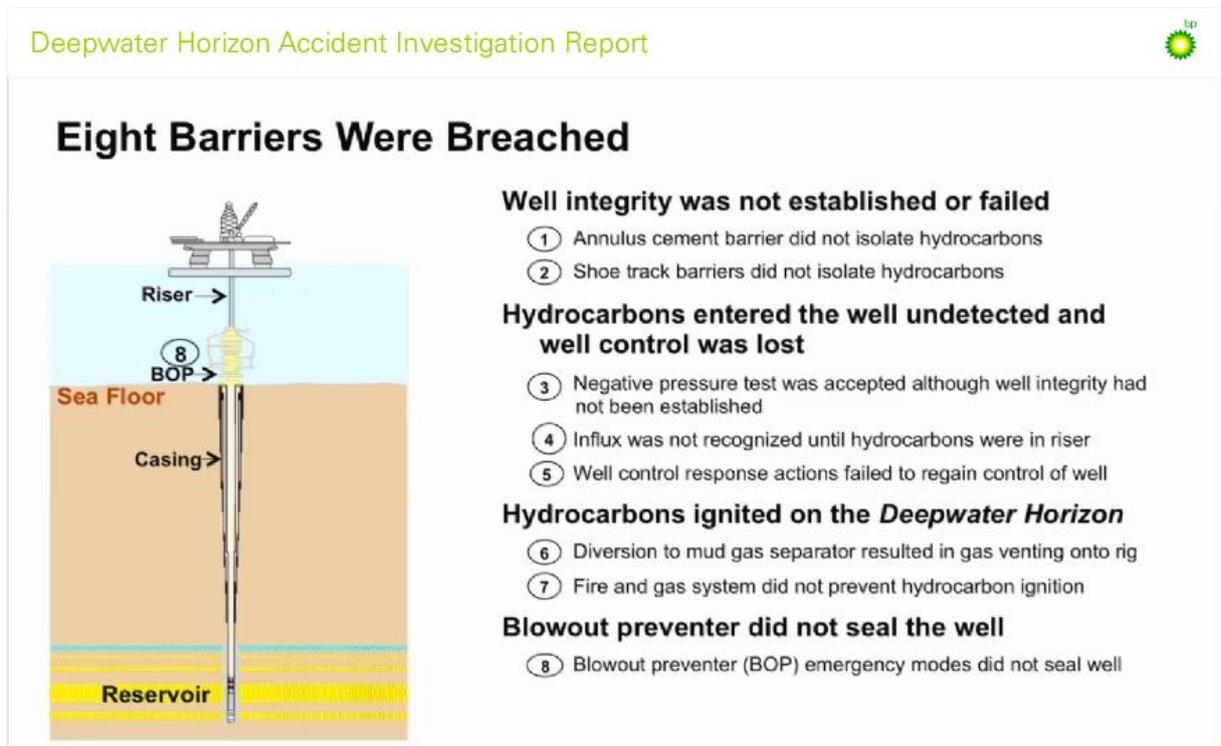
Figure 2: Key factors in accident sequence (from BP video presentation bp.com)

As shown in Figure 2, the accident analysis revealed 8 interlinked factors that contributed to the incident.

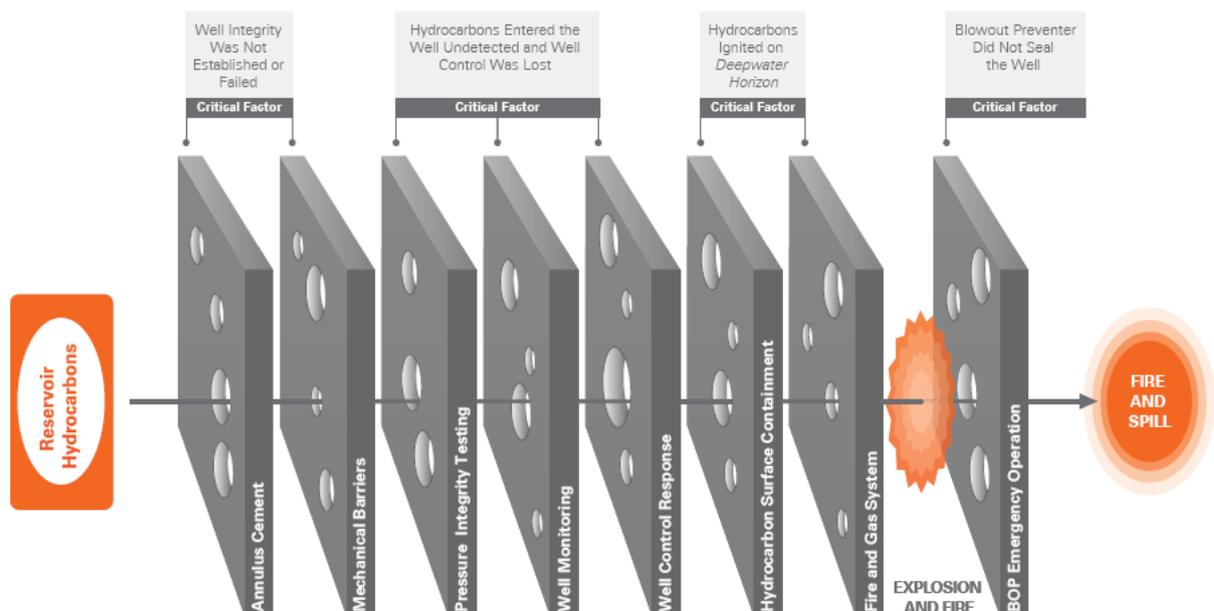
The accident report concludes that no single action caused the incident – it was a culmination of a complex interaction of mechanical failures, human judgements, engineering design, operational implementation and team communication. They use the Reason's familiar Swiss Cheese metaphor to illustrate the barriers that were breached.

The recommendations in the report focus on areas very familiar to human factors specialists such as procedure development, training, and proactive risk assessment. Specifically they include; improvements to procedures, competence assurance, Process Safety Performance Management (PSPM), which also extends to monitoring the contractors' PSPM systems, well control practices, rig process safety, and lastly BOP engineering design and assurance.
